*City of Rawlins  
Non-Motorized Rail Yard  
Grade-Separated Crossing  
Study Report*

Produced by  
AVI Professional Corporation  
In association with  
CTL Thompson

Assessment of the existing 6<sup>th</sup> Street Underpass by AVI and CTL Thompson was conducted in the fall of 2009. The assessment consisted of review of the WYDOT Bridge and Structure annual report, a topographic survey and a visual inspection of the structure. The team found the current underpass has good structural integrity but has inadequacies in the areas of safety, security, ADA accessibility, maintenance and aesthetics.

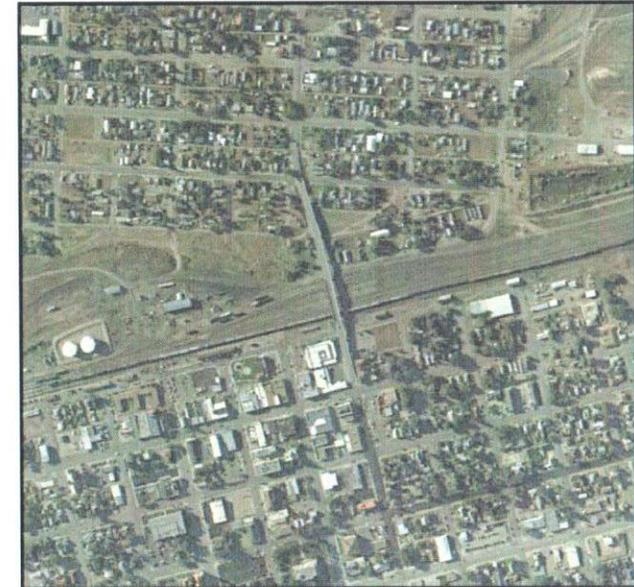
West Front Street Access

Accesses to the underpass are off Front Street on the south side of the rail yard and West Front Street Drive on the north. The West Front Street ramp access is not marked well and is dimly lit at night especially when accessing from east of tunnel. A light pole just west of the entrance does not adequately illuminate the ramp area. The picture below is a view from 6<sup>th</sup> Street vicinity facing west. The south side access is not marked well; it does appear to have better lighting in the evening hours. This is due to the additional lighting of the nearby rail yard. Both entrances are connected to the City of Rawlins pedestrian/bike path.

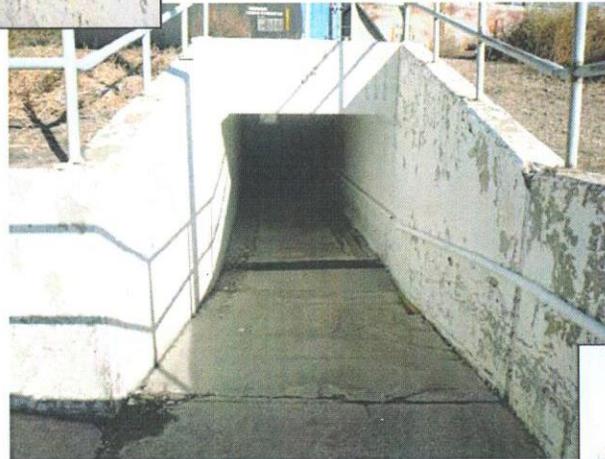
Limitations of the 6<sup>th</sup> Street Underpass include: the lighting at the entrances into the tunnel, as seen in the top photo; line of sight restrictions due to the 90 degree bends in both access ramps as seen in the middle photos; and lack of sight into the structures from the street, as shown in the bottom photo.

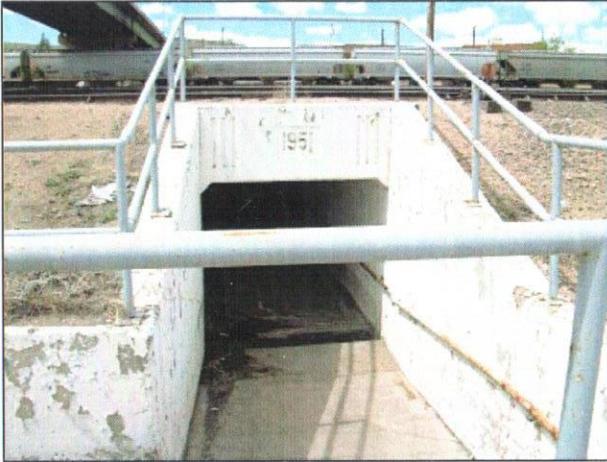
View of South Front Street Ramp with uneven concrete panels

The ramps leading into the tunnel have varying grade changes with multiple tripping hazards. Tripping hazards are un-beveled vertical changes in the floor surface greater than 1/4". Concrete slabs have either sunken or protruded over time due to cracking or joint displacement. Per ADA 28 CFR Part 36, these tripping hazards violate ADA requirements.

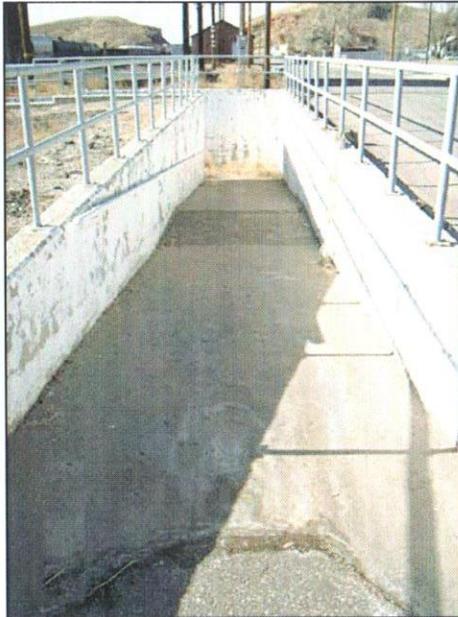
View of West Front Street Ramp with changing grade

The West Front Street ramp starts at a -12.41 percent decline for 38' then moves to 5' landing area where the grade changes to less than 1 percent slope for a distance of 30' until the 5' landing area at the 90 degree corner from there the ramp declines -3.33 percent over 39' into the tunnel body.

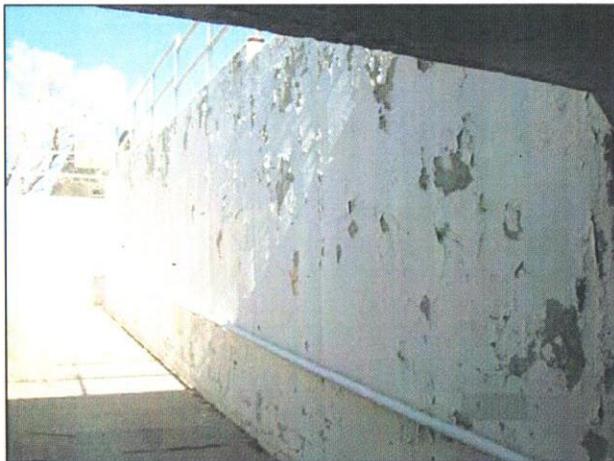
The weather in Rawlins is harsh on exposed surfaces. Regular wind speeds exceeding 30 mph, which leads to sandblasting and scouring of exposed structures. The lower left photo shows the affects of the weather on the structure. Notice the paint is peeling and weathering of the underlying concrete. Since the tunnel and access ramps are unprotected from the elements, they often fill with tumbleweeds and other debris causing additional maintenance for the City. The quantity of debris trapped in the structure can also cause unsafe conditions in the tunnel

Ramp with peeling paint and exposed concrete

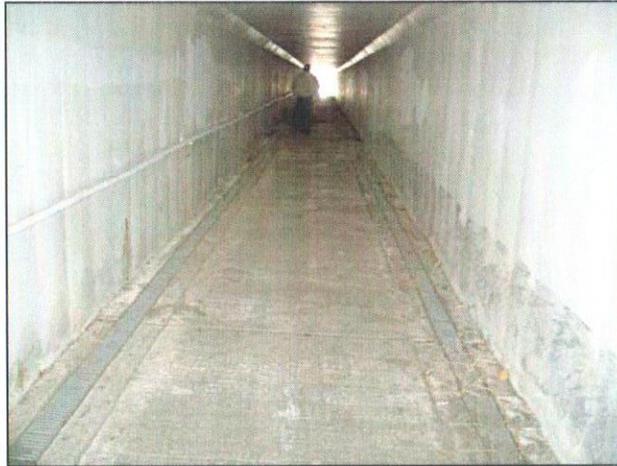
Tunnel Interior vandalism that has been painted over and slotted drains

The picture on the left shows how the City has dealt with both the vandalism and the drainage problems inside the tunnel. The City of Rawlins has repeatedly painted over the graffiti as shown in the picture.

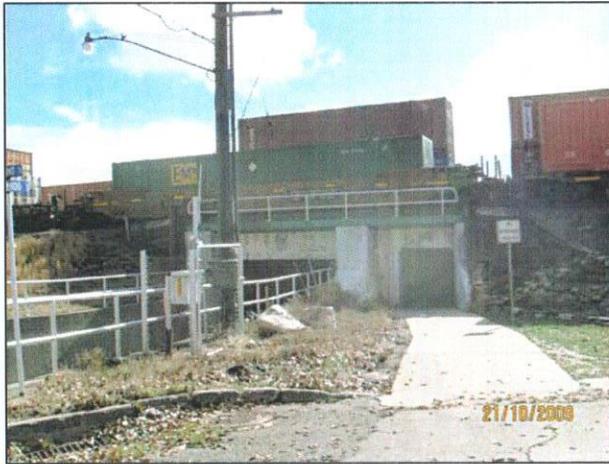
Washington Street Underpass north side

The Washington Street Underpass does meet ADA slope requirements for the access ramps into the tunnel on the north side. The ramp is at an approximate 4.9 percent decline into the tunnel. The ramp into the tunnel is in good shape except for slight grade changes across the pavement.

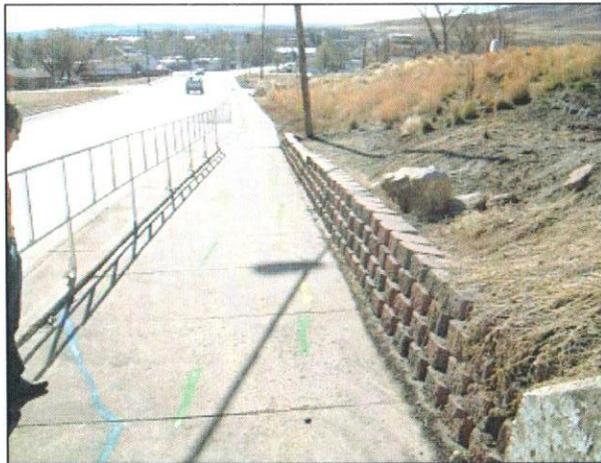
The Washington Street Underpass south side access ramp does not meet ADA grade requirements. The ramp is approximate 73' long and at a 9.4 percent increase into the tunnel. The ramp into the tunnel appears to be recently placed and is in good condition except for ADA non-compliance of the access ramp.

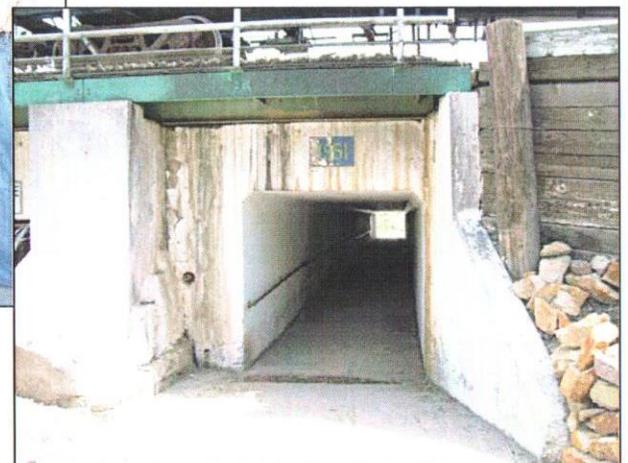
The bottom photo shows the exposure to rail yard runoff onto the face of the north side tunnel entrance. The opening is stained from the runoff. The paint on the exterior of the entrance is peeling due to exposure to the weather.
