*City of Rawlins  
Non-Motorized Rail Yard  
Grade-Separated Crossing  
Study Report*

Produced by  
AVI Professional Corporation  
In association with  
CTL Thompson

Assessment of the existing 6<sup>th</sup> Street Underpass by AVI and CTL Thompson was conducted in the fall of 2009. The assessment consisted of review of the WYDOT Bridge and Structure annual report, a topographic survey and a visual inspection of the structure. The team found the current underpass has good structural integrity but has inadequacies in the areas of safety, security, ADA accessibility, maintenance and aesthetics.

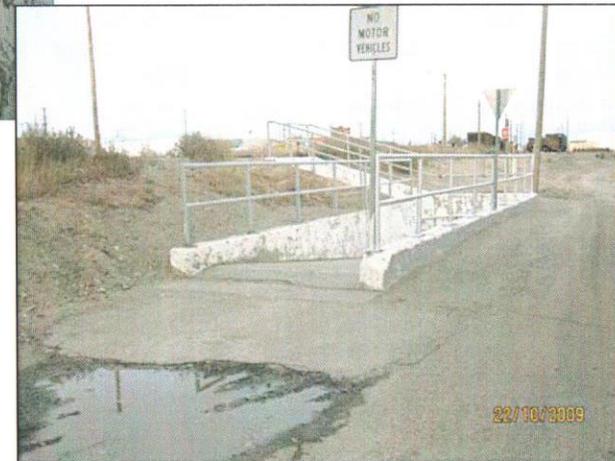
View of South Front Street Ramp with uneven concrete panels

The ramps leading into the tunnel have varying grade changes with multiple tripping hazards. Tripping hazards are un-beveled vertical changes in the floor surface greater than 1/4". Concrete slabs have either sunken or protruded over time due to cracking or joint displacement. Per ADA 28 CFR Part 36, these tripping hazards violate ADA requirements.

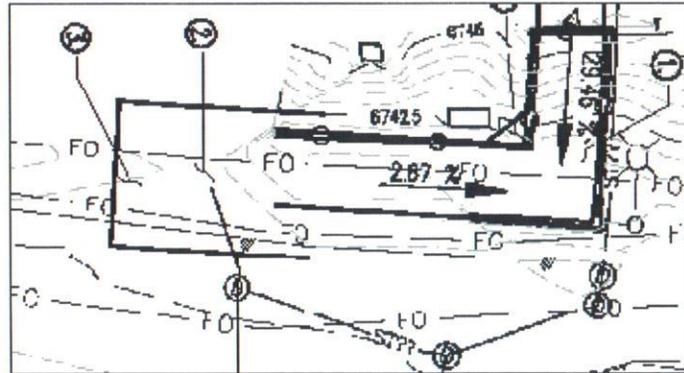
Portions of both access ramps for the 6<sup>th</sup> Street Underpass meet ADA slope requirements. Ramps are continuous entities and the whole structure must comply with slope requirements before it is in compliance with the Section 4.8 of 28 CFR part 36. Portions of the ramp exceeding 8.33% slope violate ADA specifications.

The South Front Street ramp starts at a -2.67 percent decline for 36' until the 90 degree corner and 5' landing area then declines at a -29.46 percent slope for 14' into the tunnel. Total ramp distance is 55 feet.

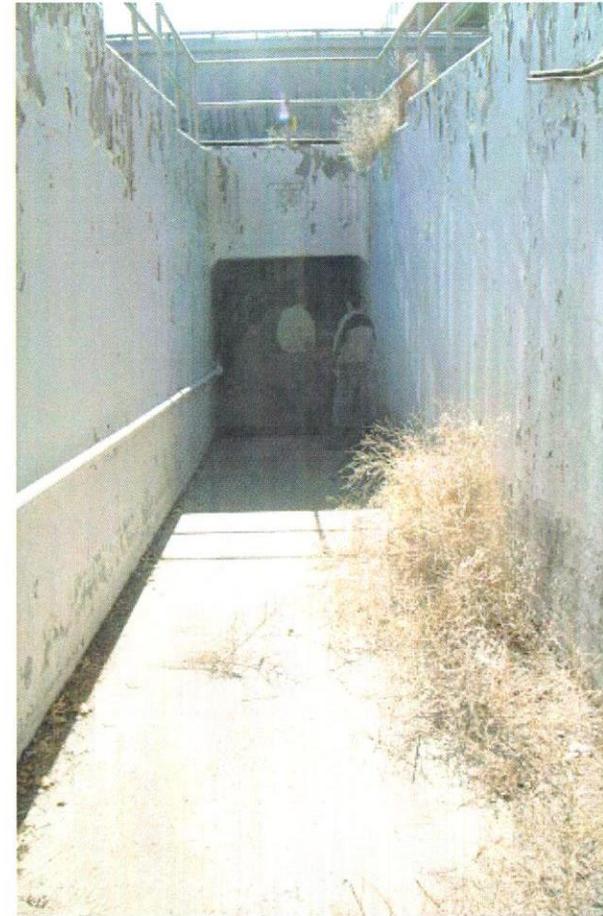
The weather in Rawlins is harsh on exposed surfaces. Regular wind speeds exceeding 30 mph, which leads to sandblasting and scouring of exposed structures. The lower left photo shows the affects of the weather on the structure. Notice the paint is peeling and weathering of the underlying concrete. Since the tunnel and access ramps are unprotected from the elements, they often fill with tumbleweeds and other debris causing additional maintenance for the City. The quantity of debris trapped in the structure can also cause unsafe conditions in the tunnel

Ramp with peeling paint and exposed concrete

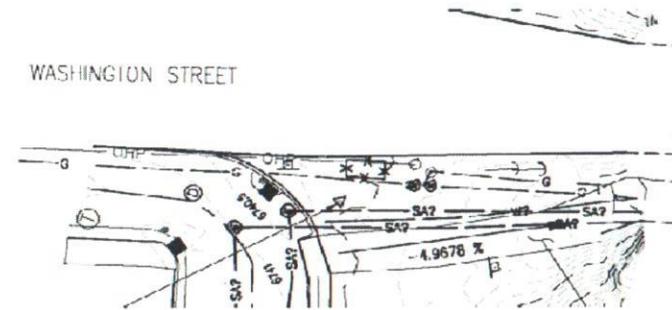
The Washington Street Underpass does meet ADA slope requirements for the access ramps into the tunnel on the north side. The ramp is at an approximate 4.9 percent decline into the tunnel. The ramp into the tunnel is in good shape except for slight grade changes across the pavement.

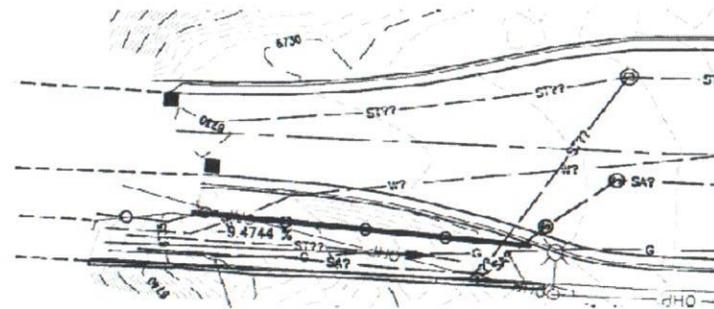
The Washington Street Underpass south side access ramp does not meet ADA grade requirements. The ramp is approximate 73' long and at a 9.4 percent increase into the tunnel. The ramp into the tunnel appears to be recently placed and is in good condition except for ADA non-compliance of the access ramp.

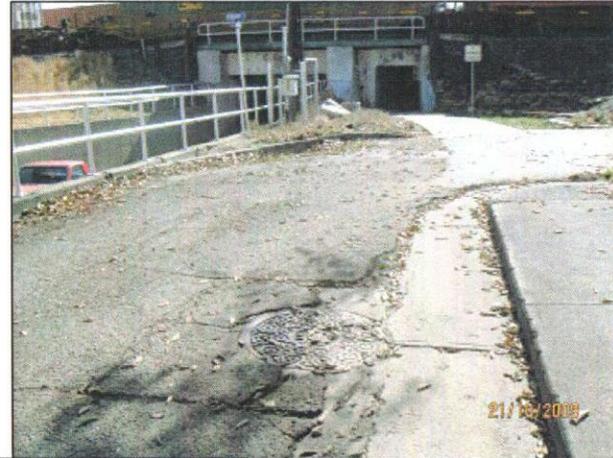
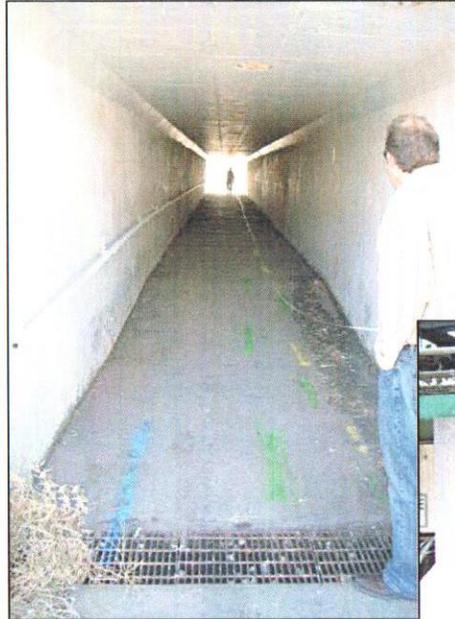
Hand rails for the Washington Street Underpass are missing from the north side access ramp into the tunnel. The rail inside the tunnel is loose in areas. A second hand rail on the south side is required due to the steep grade of the ramp. The existing hand rail on the south side does meet compliance of the Section 4.8.5 of the 28 CFR Part 36.

The bottom photo shows the exposure to rail yard runoff onto the face of the north side tunnel entrance. The opening is stained from the runoff. The paint on the exterior of the entrance is peeling due to exposure to the weather.

Vandalism and graffiti has been observed at a few places within the structure.
